OAK RIDGE NATIONAL LAB TN

ORNL-5541

**Blast Tests of Expedient
Shelters in the Misers
Bluff Event**

FINAL REPORT • JANUARY 1980

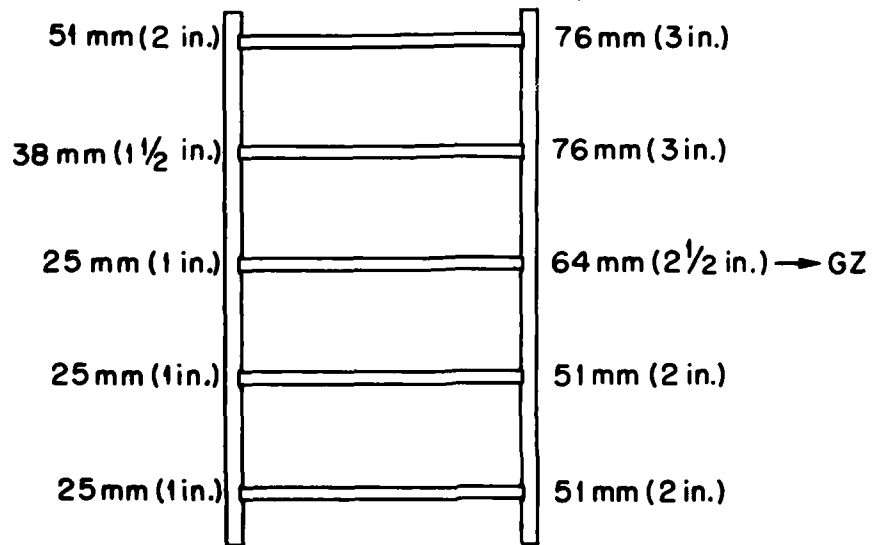
ORNL-DWG 79-14930

Fig. 6.13. Diagrammatic sketch giving the post blast vertical distances between points on the upper ladder-like brace and roof poles of the detached Small-Pole Shelter room.

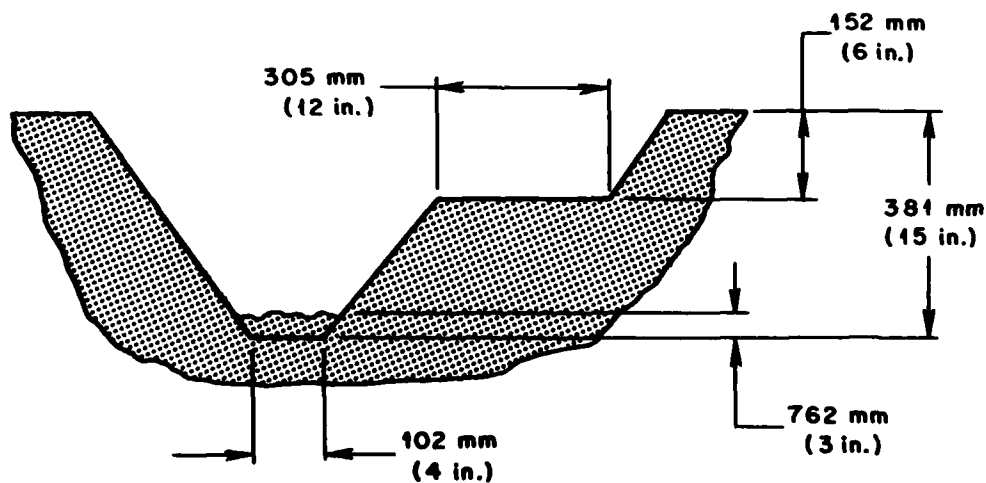
ORNL-DWG 79-18258

Fig. 7.11. Postblast dimensions of the unshored earth seat and foot trench.
